ULTRASONIC INSPECTION OF CERAMICS CONTAINING SMALL FLAWS.(U)

MAR 77 T DERKACS, I M MATAY, W D BRENTNALL

TRW-ER-7867-F

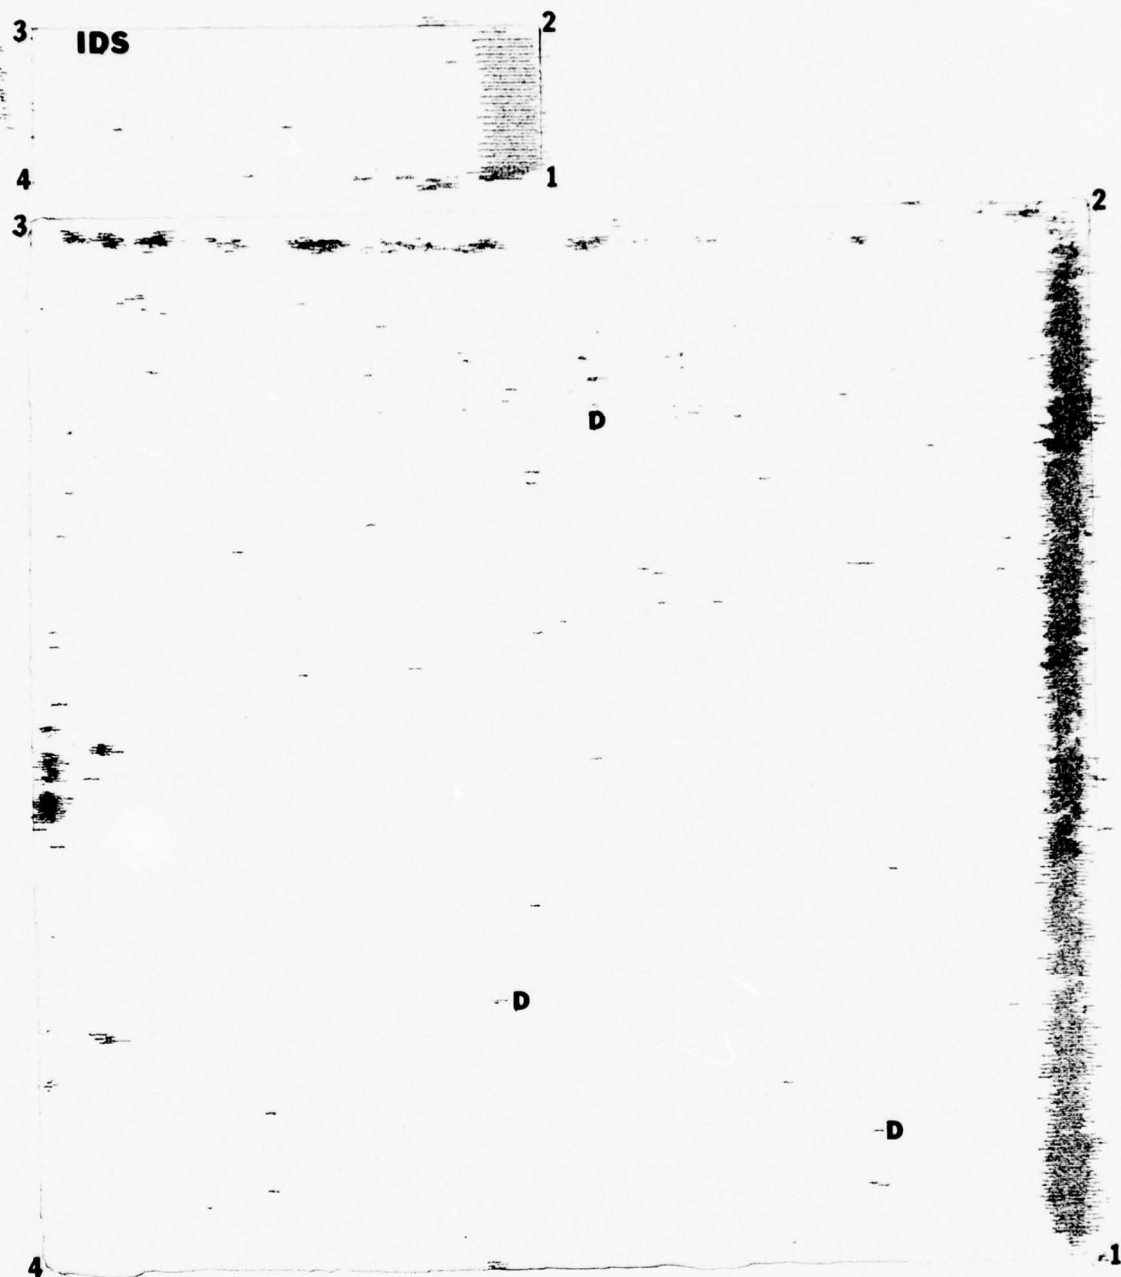
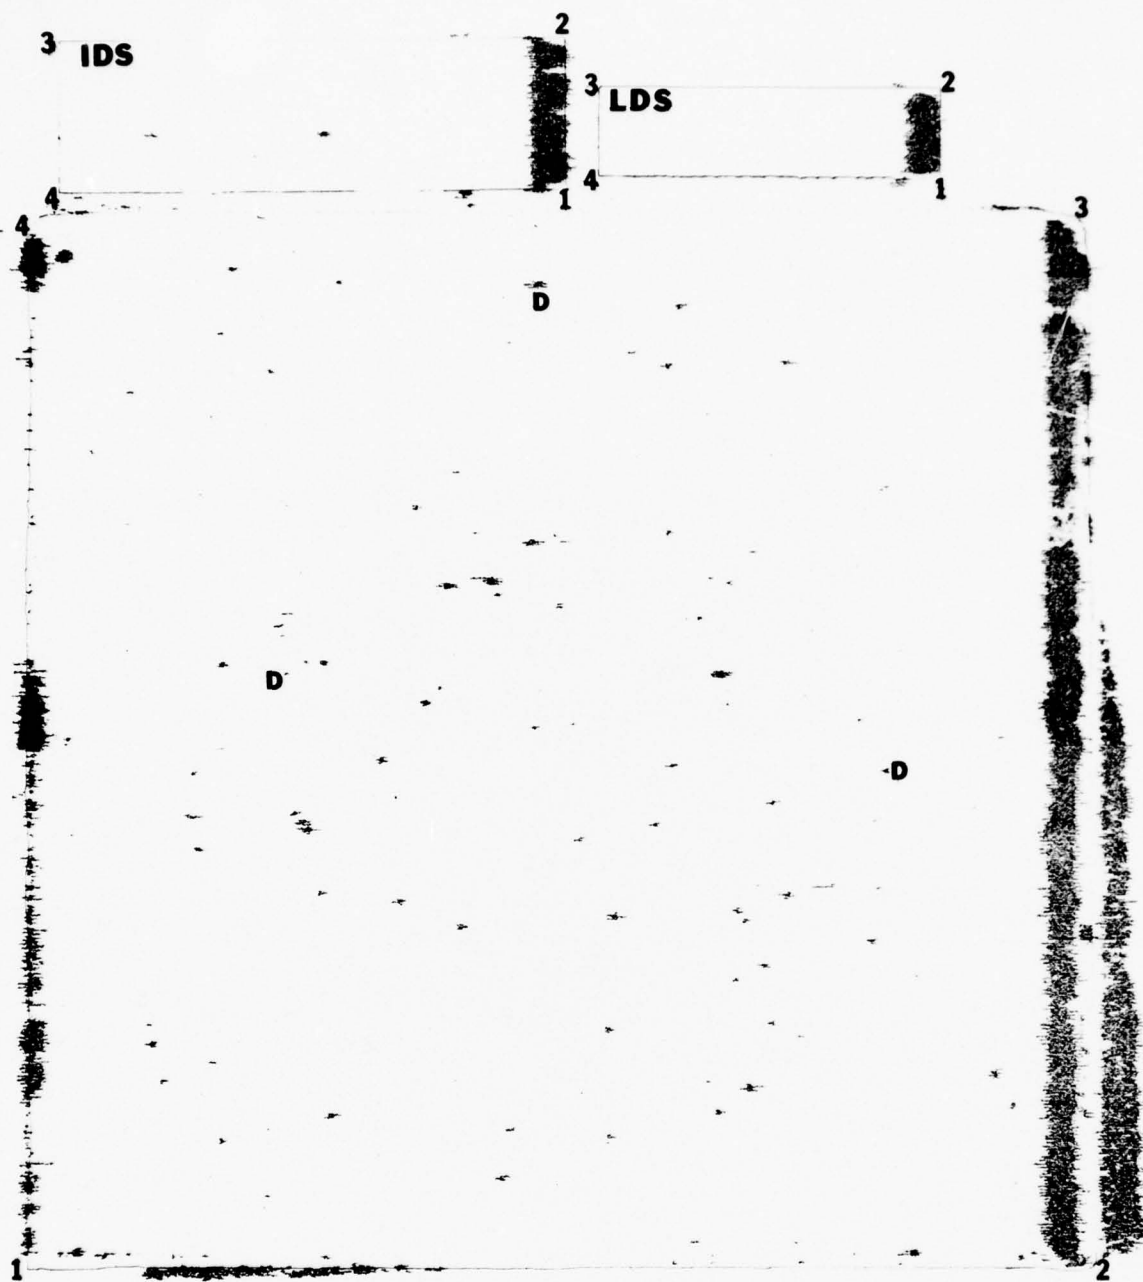
Figures 6 through 13 show some typical C-scan recordings that illustrate the results observed for the materials that were inspected before and after surface machining. Figures 6 and 7 are C-scan recordings of the Ceralloy 147A at 45 MHz using an 11° angle of incidence. The single gate width technique was used. In these two figures four indications are labelled with the letter D indicating that they are internal defects that appear in both scans. All the other indications in Figure 6 are due to surface defects. The other indications in Figure 7 are mostly internal defects that were not previously detected. Some are defects in the new surface. Figures 8 and 9 are C-scan recordings of ultrasonic longitudinal wave inspections of NC-132 at 45 MHz before and after machining. Figure 8 shows extensive areas of surface related indications caused by pitting. In Figure 9, the one internal defect detected is labelled D. The other indications are caused by flaws in the new surface. Figures 10 through 13 are C-scan recordings of longitudinal and shear wave inspections of the NC-203A at 45 MHz before and after machining. This billet had an area of surface porosity near the center on both sides before

Figure 6. C-scan Recording of 45 MHz, 11° Ultrasonic Shear Wave Inspection of Ceralloy 147A Before Machining.

Figure 7. C-scan Recording of 45 MHz, 11° Ultrasonic Shear Wave Inspection of Ceralloy 147A after Machining.

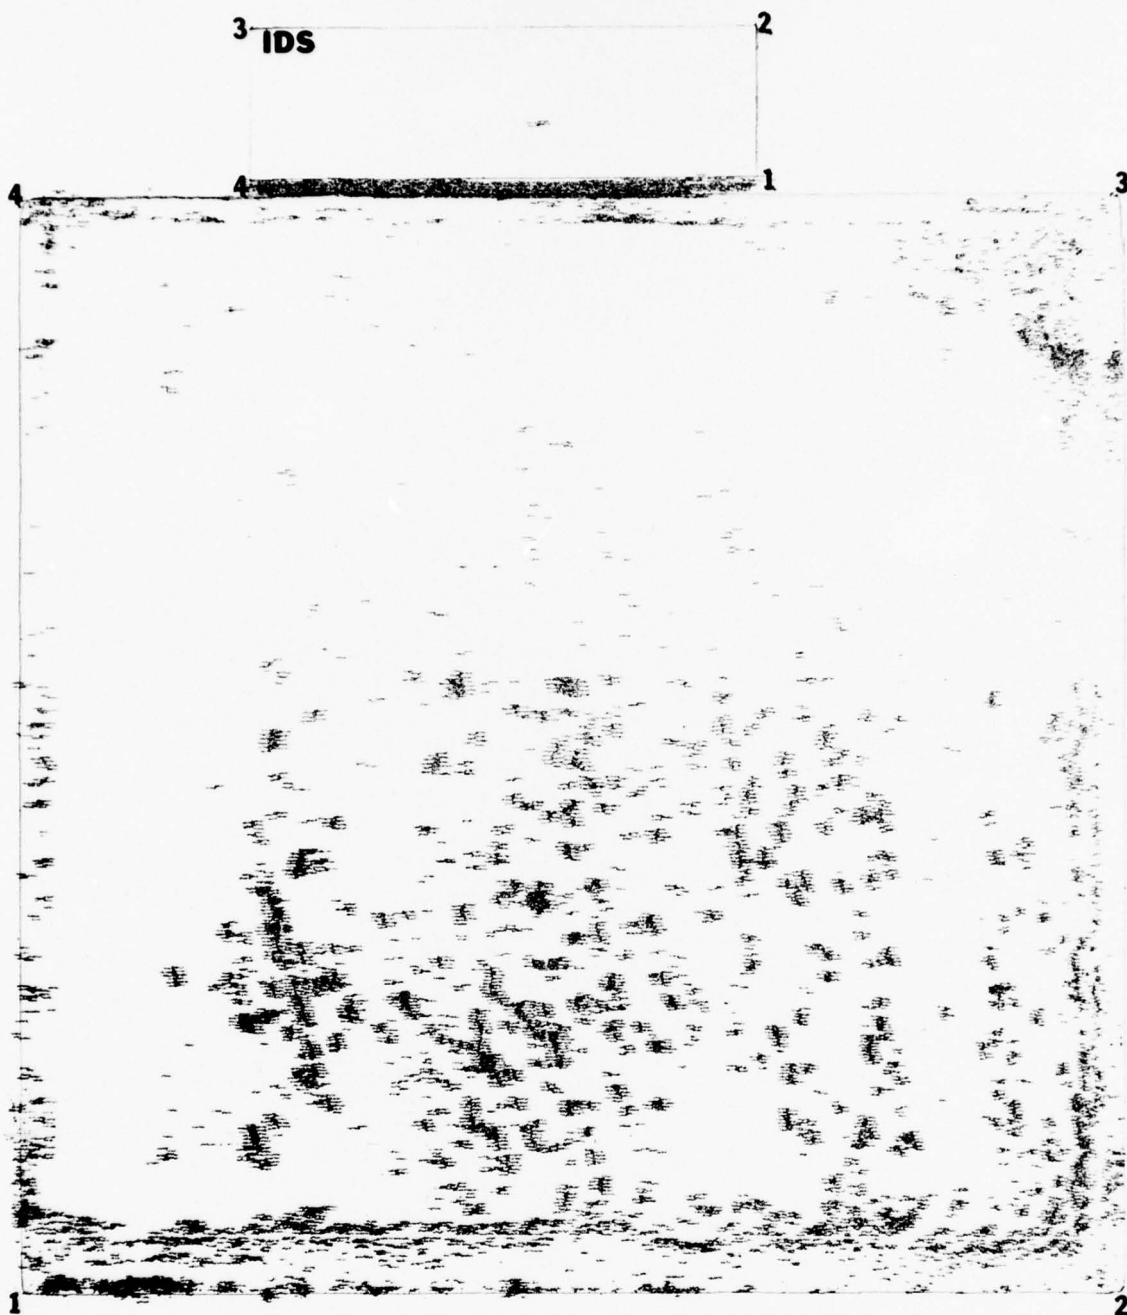
Figure 8. C-scan Recording of 45 MHz Longitudinal Wave Inspection of NC-132 Before Machining.

The billet of NC-132 was also relatively free of defects. In addition to one small defect detected by longitudinal wave inspection (labelled D in Figure 9), a number of mostly small defects were detected by the shear wave technique (Figures 17 and 18). These two figures show C-scan recordings for shear wave inspections made at two orientations 90° apart. The indications labelled D appear in both figures. Subsequent measurements of defect depths revealed most of these indications to be the result of residual surface pits that were too deep to remove by surface machining. In contrast, the billet of Ceralloy 147A was found to have a large number of defects scattered throughout the part (Figure 14). Because of the large number of scans and the large number of defects in each scan, it is difficult to present an overall recording of the inspection results on this billet which would clearly distinguish the circumstances under which each defect is detected. However, Figures 19 and 20 summarize the

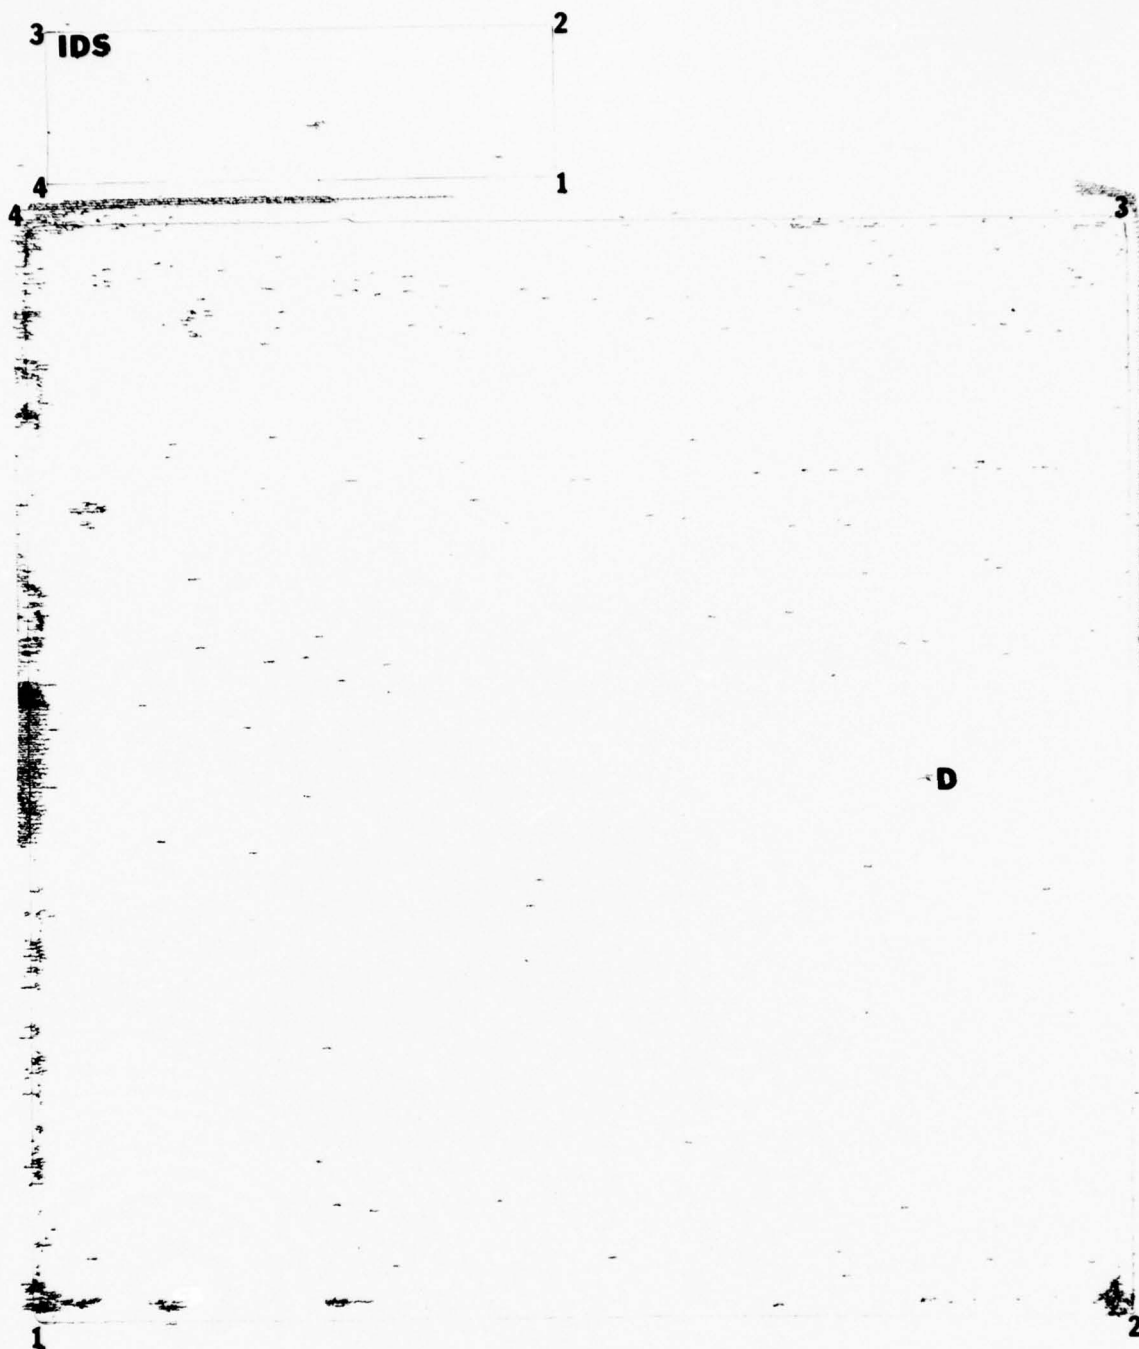
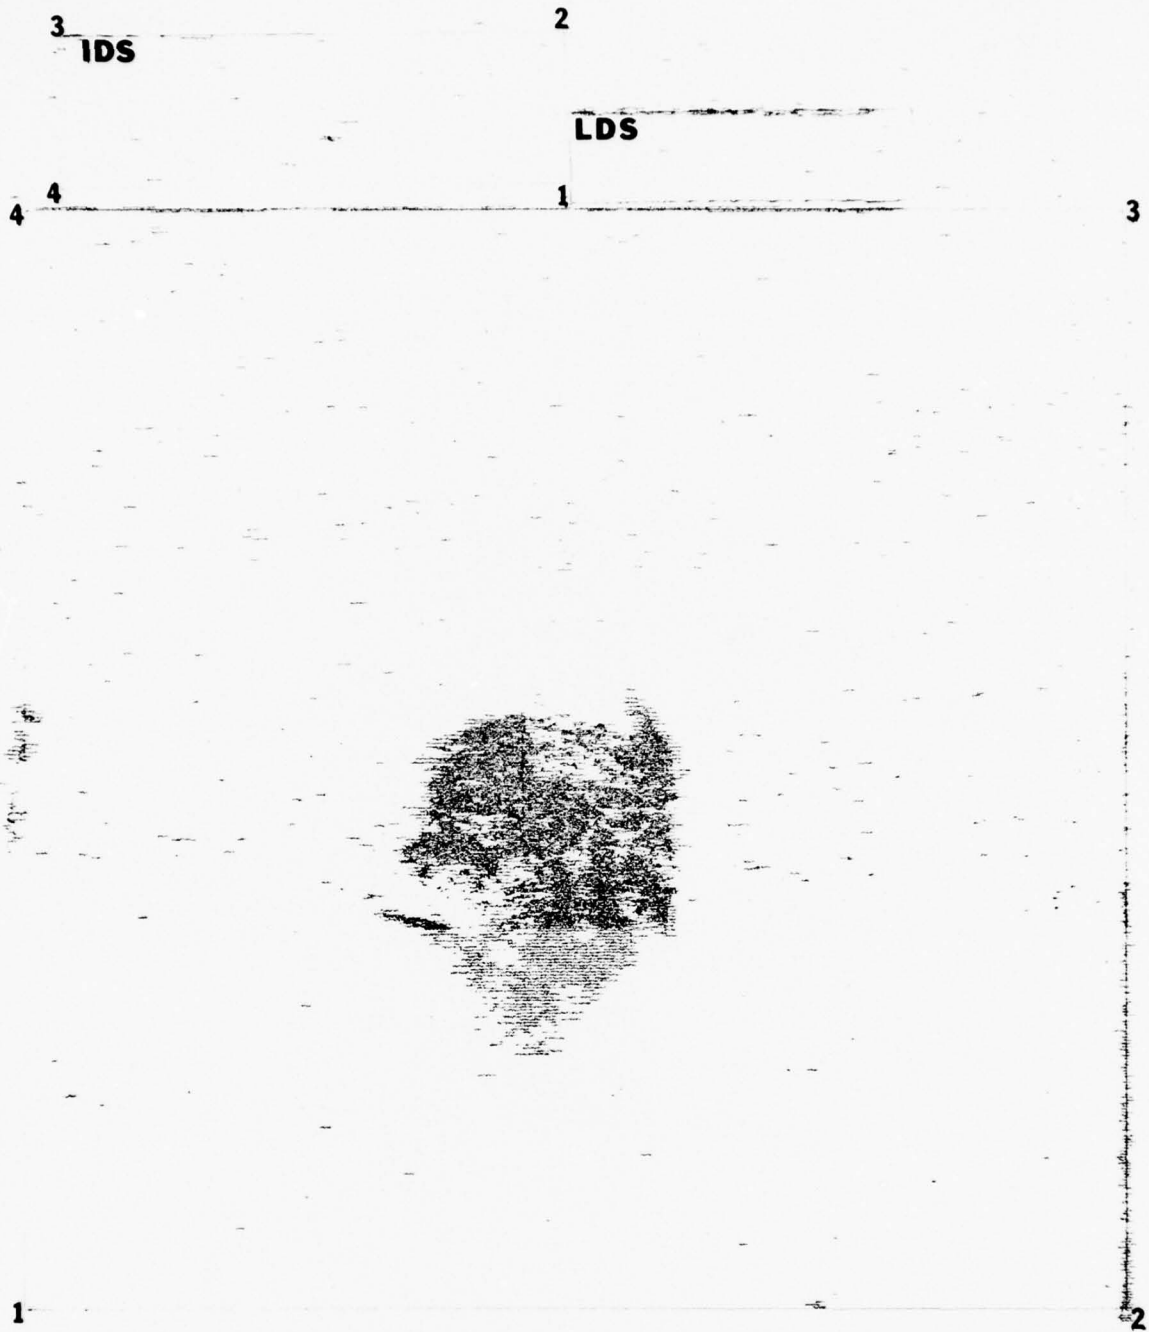
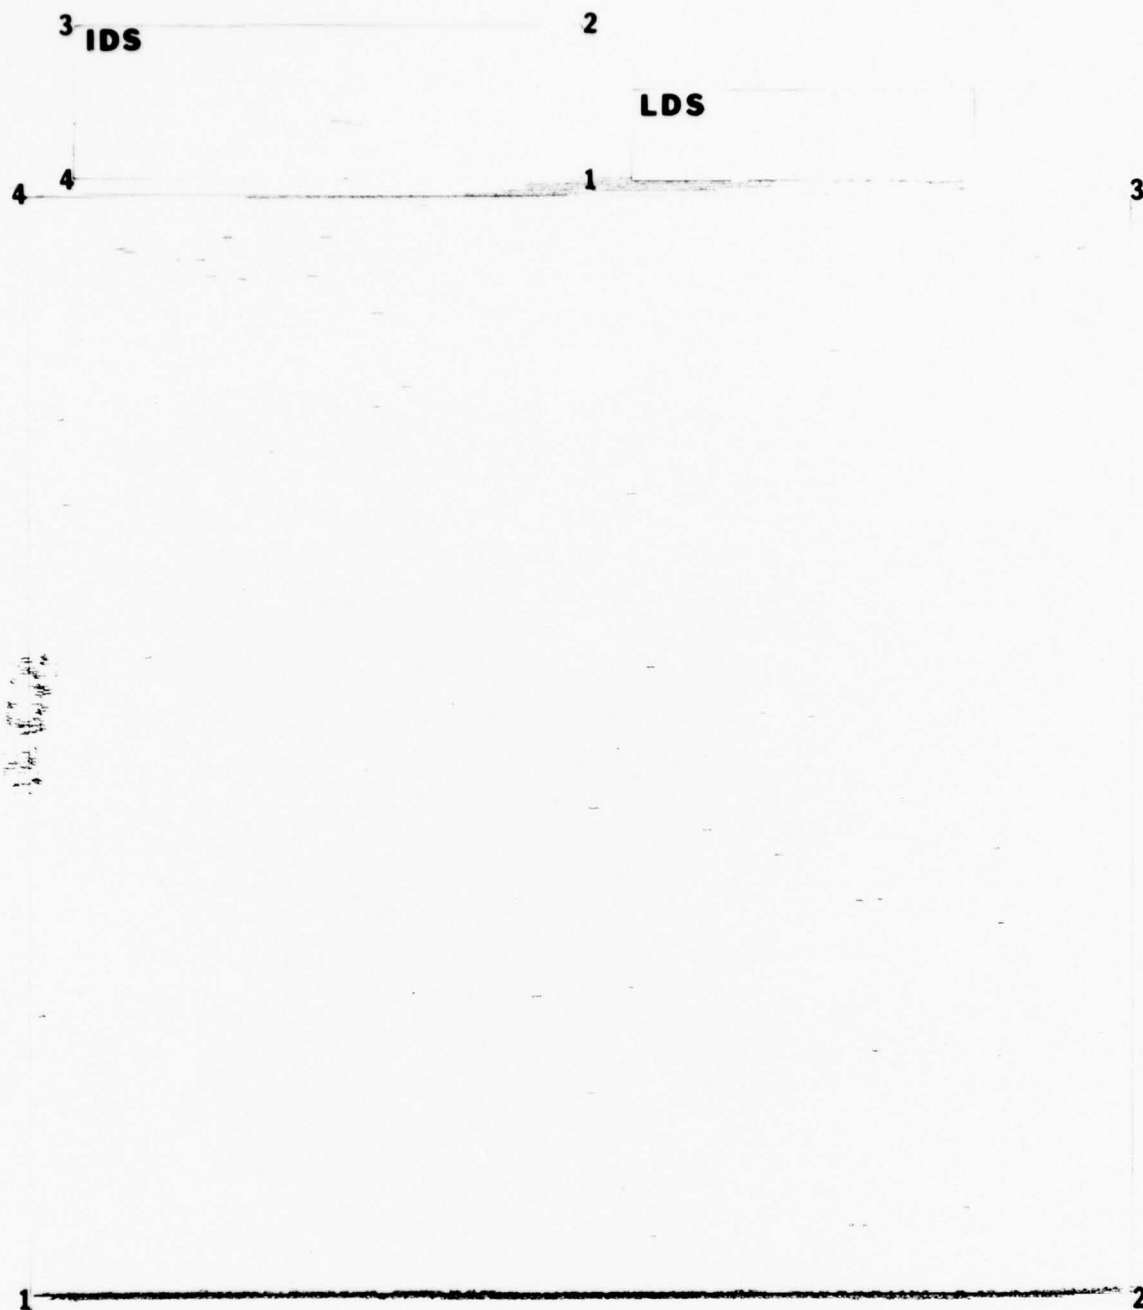
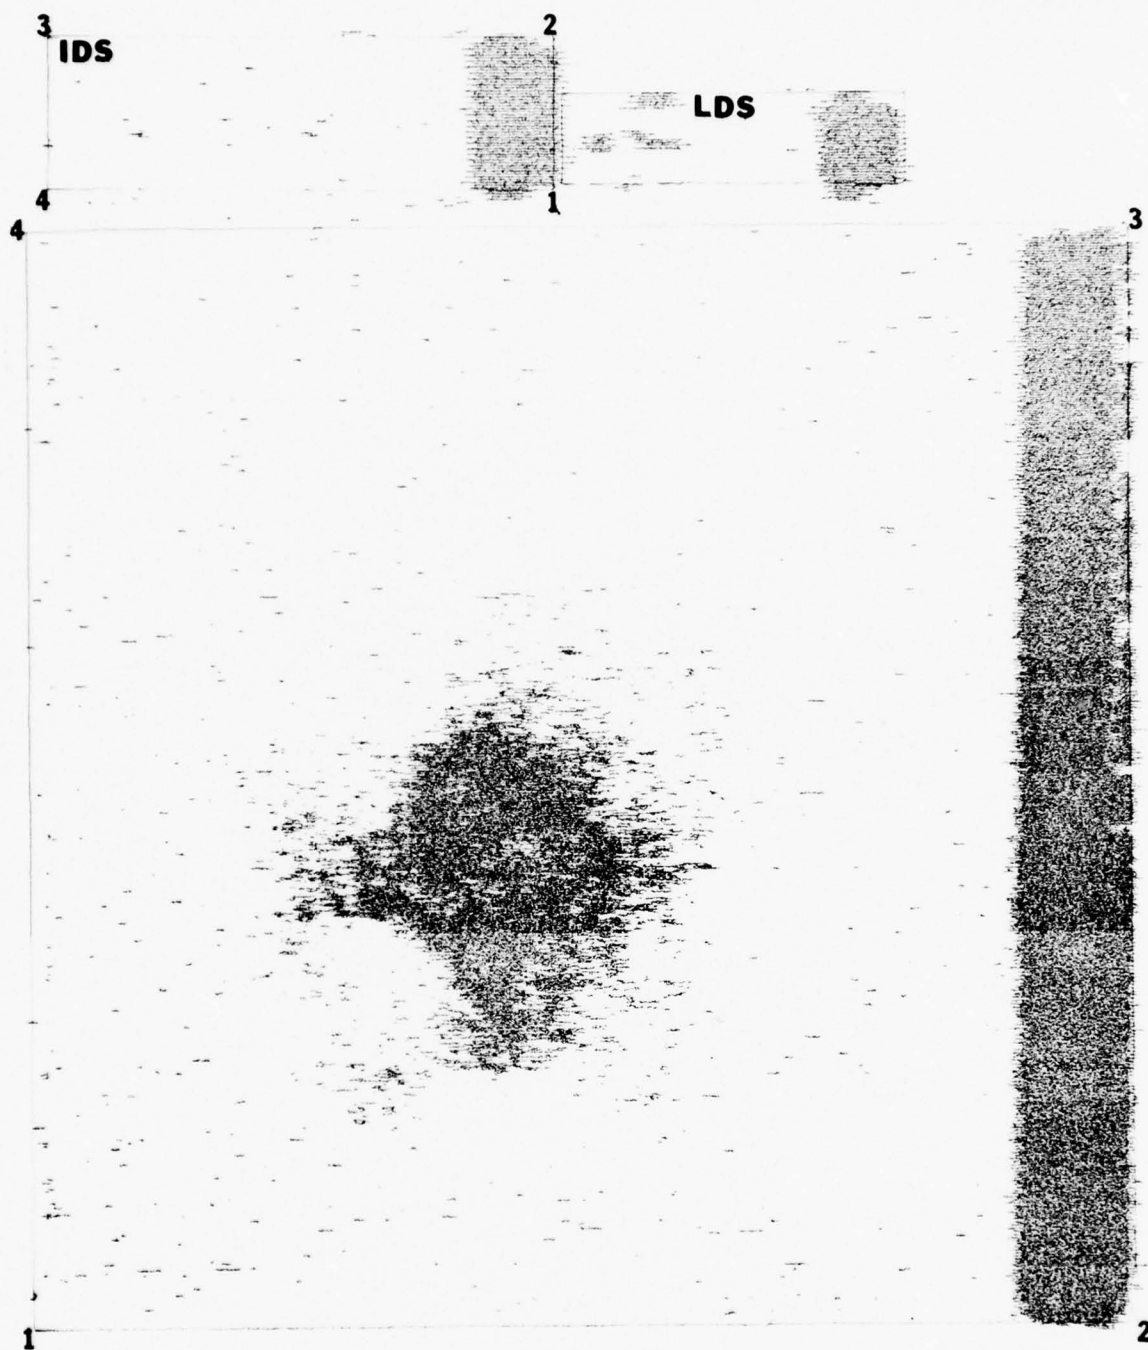
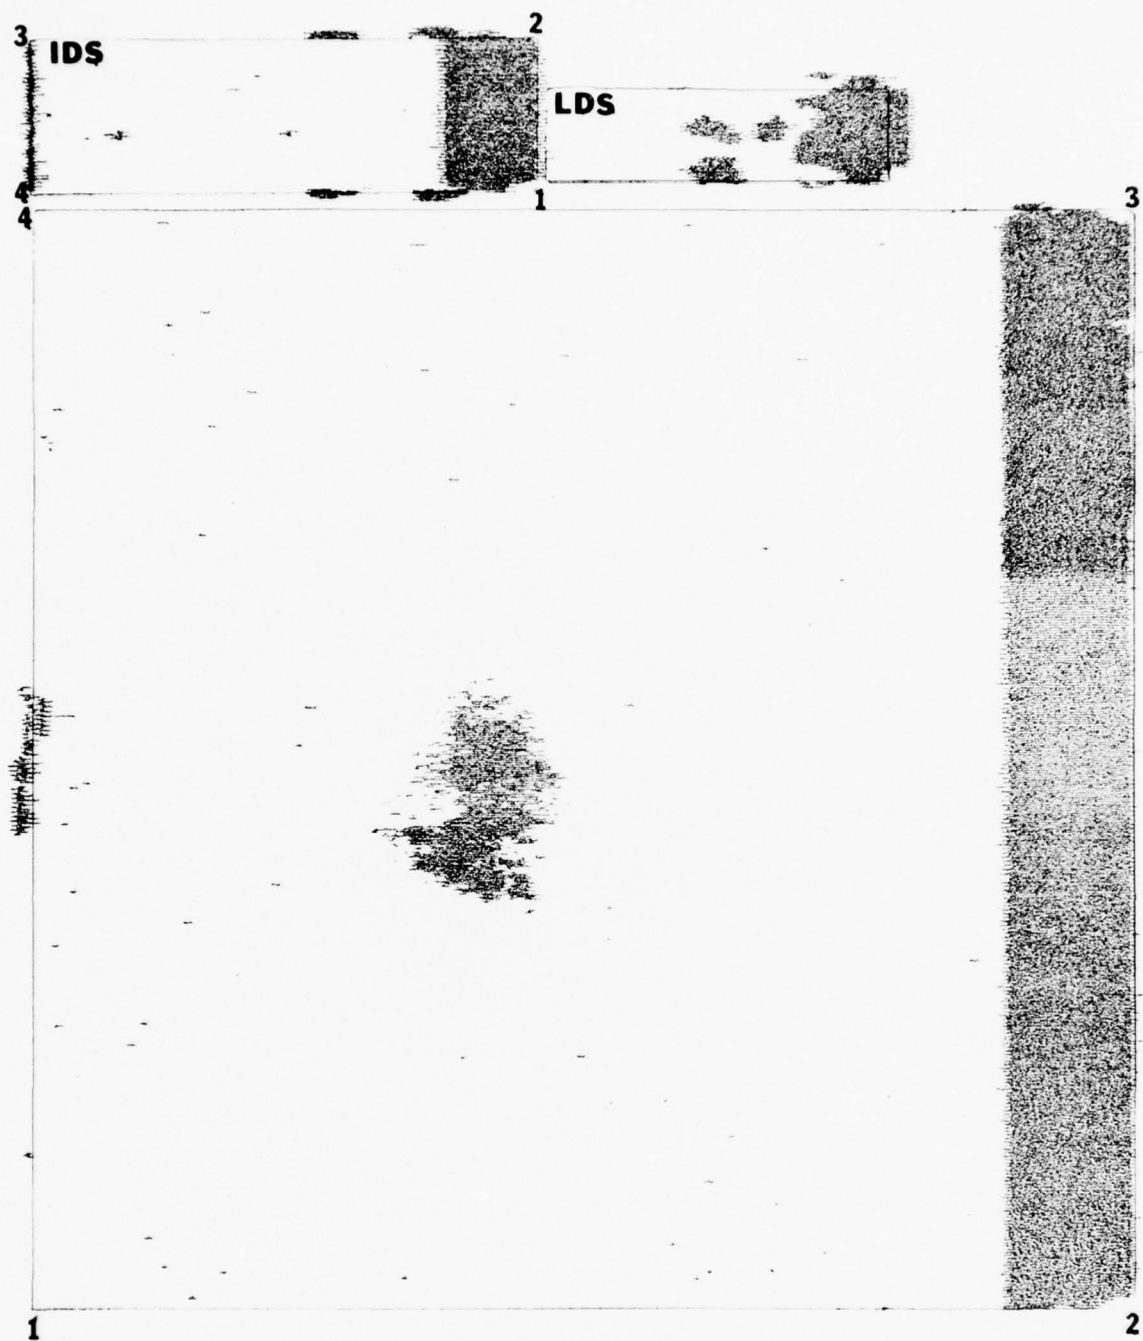
Figure 9. C-scan Recording of 45 MHz Longitudinal Wave Inspection of NC-132 After Machining.

Figure 10. C-scan Recording of 45 MHz Longitudinal Wave Inspection of NC-203A Before Machining.

Figure 11. C-scan Recording of 45 MHz Longitudinal Wave Inspection of NC-203A After Machining.

Figure 12. C-scan Recording of 45 MHz, 11° Shear Wave Inspection of NC-203A Before Machining.

Figure 13. C-scan Recording of 45 MHz, 11° Shear Wave Inspection of NC-203A After Machining.

machining. After machining a smaller area remained on the bottom side as these scans were made. As can be seen in Figure 11, the longitudinal wave inspection with the beam focused at the center of the billet did not detect the area of porosity on the bottom side. The shear wave inspection (Figure 13), however, did detect the porosity near the bottom surface.

It is concluded from these inspections that significant surface flaws cause indications on the C-scans, but they also can mask internal defects. How much this effect might be a problem on an actual part, such as an airfoil, will have to be further evaluated. Surface flaws, as large as the ones removed by machining these specimens, are likely to be more serious than the internal flaws they mask.

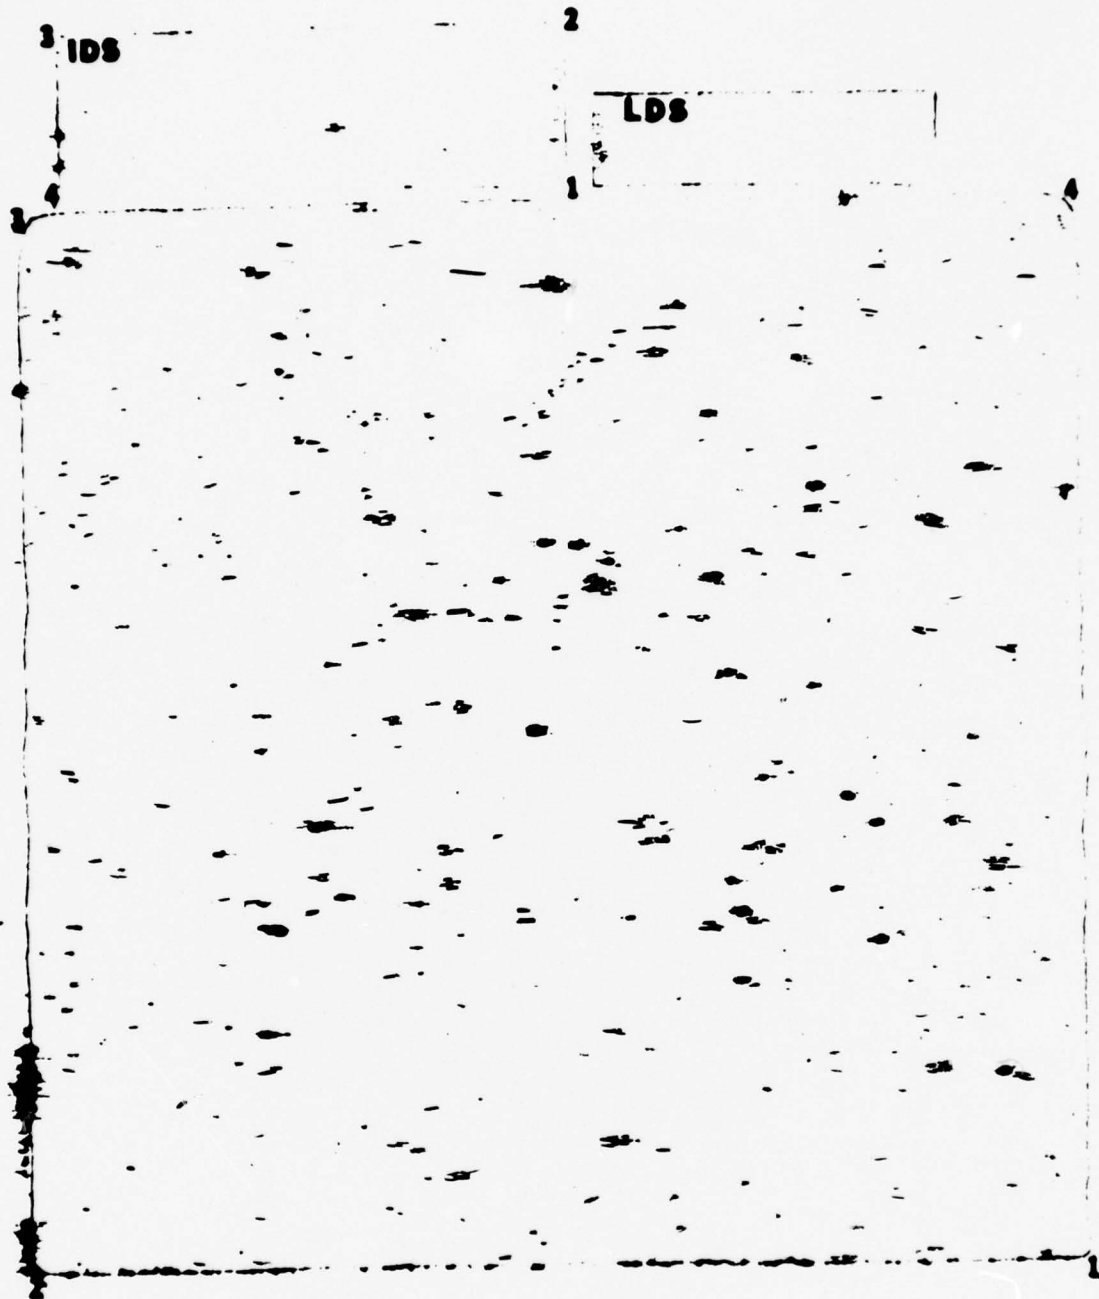
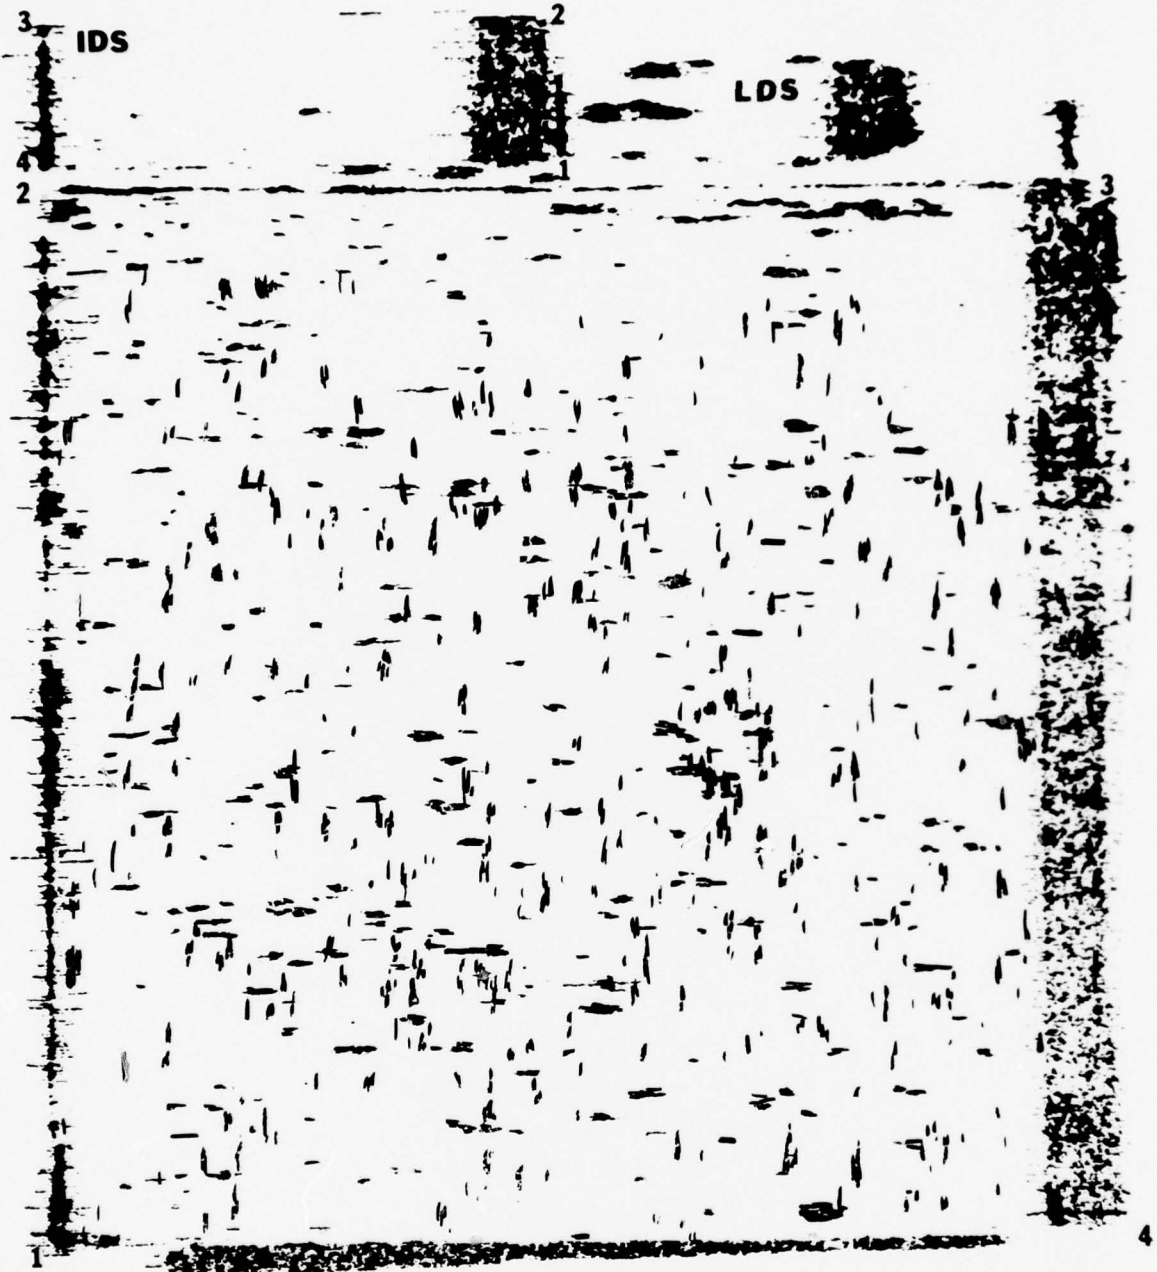
Figure 19. Composite C-scan Recording of Three 45 MHz Longitudinal Wave Inspections of the Billet of Ceralloy 147A.

Figure 20. Composite C-scan Recording of Four 45 MHz, 11° Shear Wave Inspections of the Billet of Ceralloy 147A.

results of the longitudinal and shear wave inspections, respectively. Each figure was made by making a transparency from one C-scan recording and then laying that over the other C-scan recordings and tracing any new indications. Figure 19, therefore, is a composite of the three longitudinal wave inspections made at three different focal planes, while Figure 20 is a composite of the four shear wave inspections made at two orientations at each of two focal planes. In Figure 20 it should be noted that a number of cases exist where indications form a + or L shape. These are caused by defects that are detected from two different orientations 90° apart. The exact relationship between the two indications depends on the depth of the defect and on whether it was detected by the beam going down or up or both. By overlapping the two transparencies from which these figures were made the defects were identified that were only detected by shear wave inspection.

The results indicate that defect orientation has a significant effect, as expected, and that a number of scans are required to obtain complete part defect coverage.

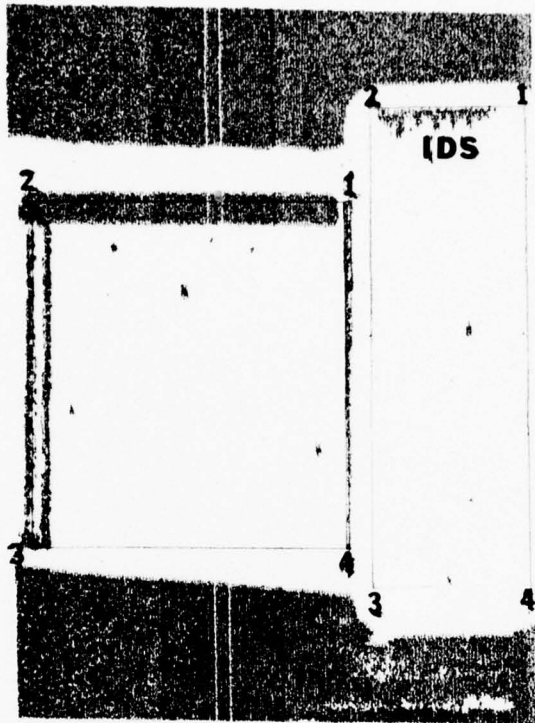
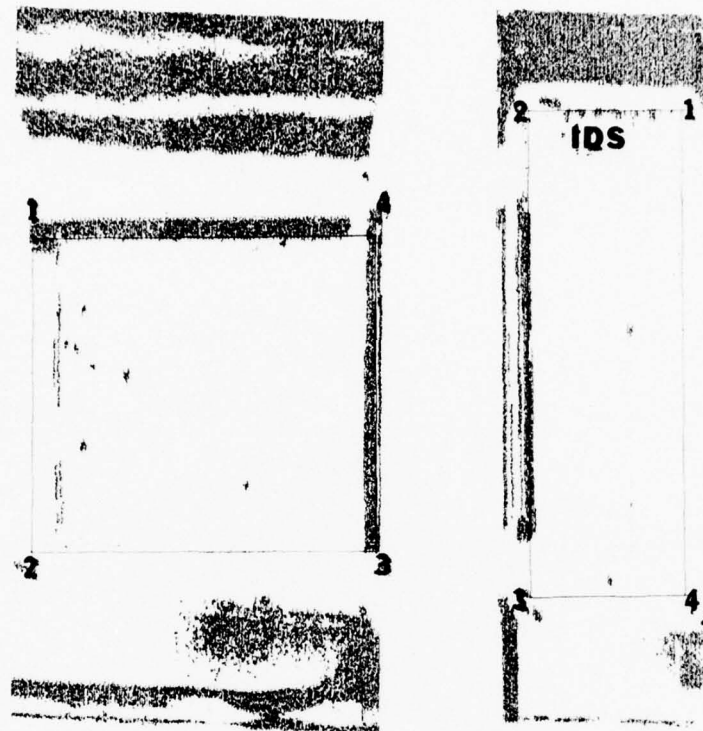
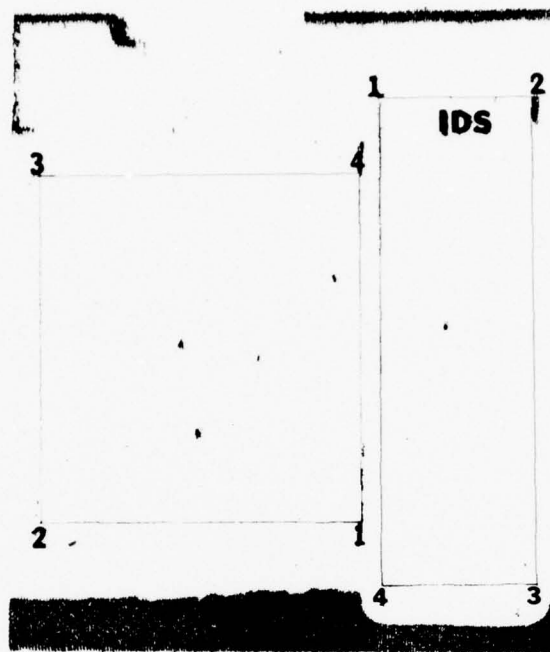
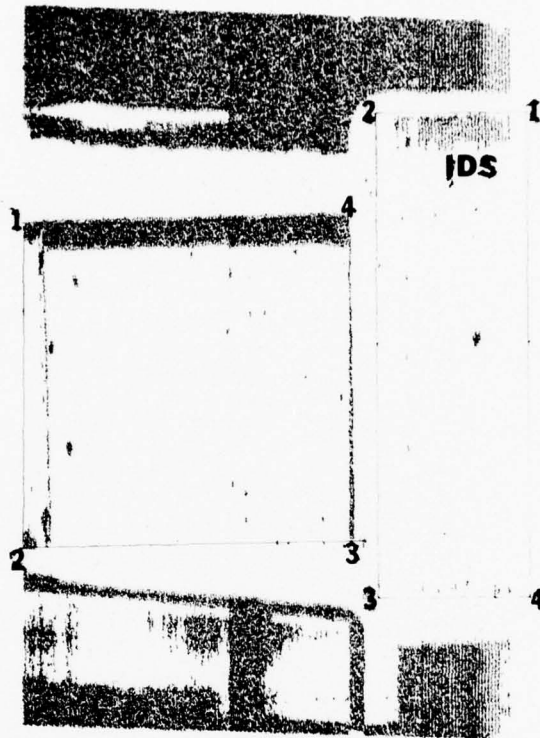
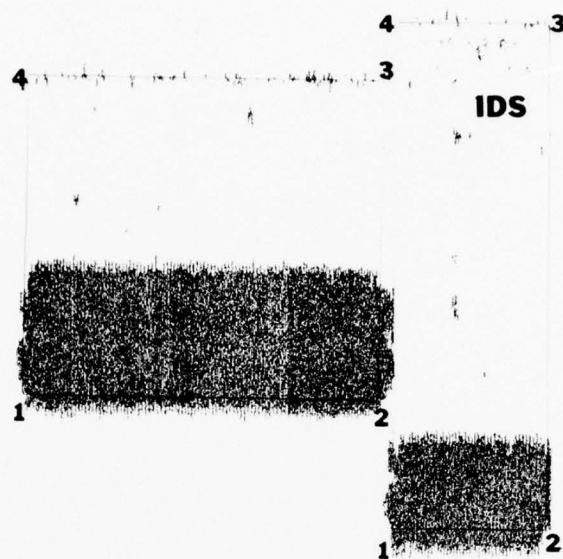
Figure 21. C-scan Recording of Ultrasonic Longitudinal Wave Inspection of Sintered Silicon Carbide Billet and Internal Defect Standard (IDS) at a Frequency of 45 MHz with a Water Path of 17 mm.

Figure 22. C-scan Recording of Ultrasonic Longitudinal Wave Inspection of Sintered Silicon Carbide Billet and Internal Defect Standard at a Frequency of 45 MHz with a Water Path of 17 mm.

Figure 23. C-scan recording of Ultrasonic Longitudinal Wave Inspection of Sintered Silicon Carbide Billet and Internal Defect Standard at a Frequency of 5 mm (Top Side Down).

Figure 24. C-scan recording of Ultrasonic Longitudinal Wave Inspection of Sintered Silicon Carbide Billet and Internal Defect Standard at a Frequency of 45 MHz with a Water Path of 5 mm.

Figure 25. C-scan Recording of 45 MHz, 11° Shear Wave Inspection of Sintered Silicon Carbide Billet.

of high frequency ultrasonic inspection to detect the few small pores that are expected to be in this already well-characterized material. The four longitudinal scans revealed twenty-one different defects. The shear wave inspection showed five defects, three of which had not previously been detected, bringing that total to twenty-four. This is about double the number of pores the manufacturer expected to find in this sample. Further evaluations will be required to determine the reason for this unexpected result.

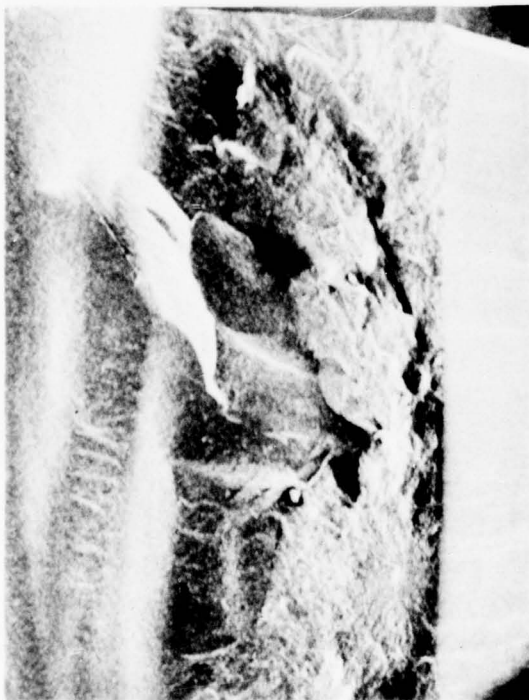
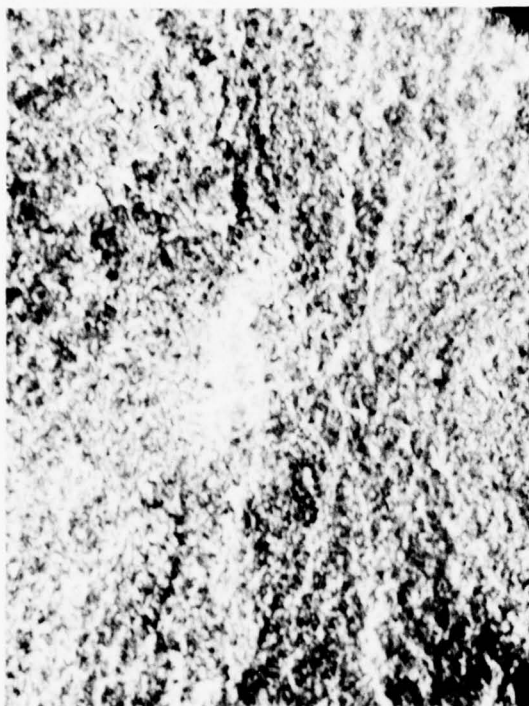
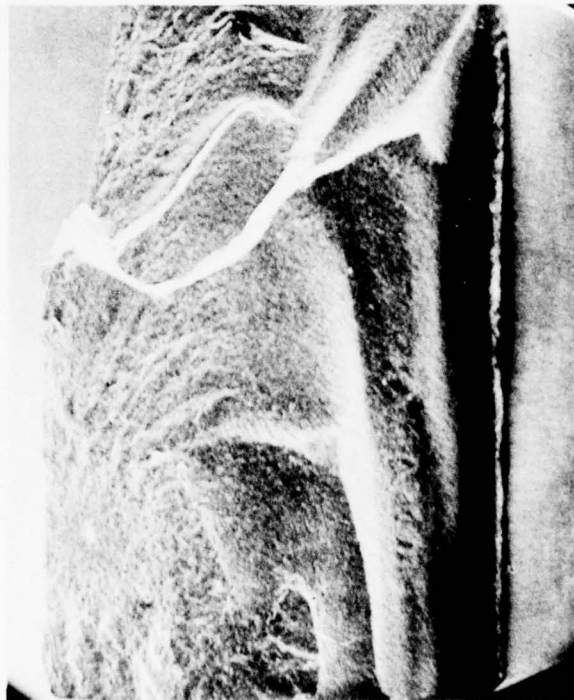
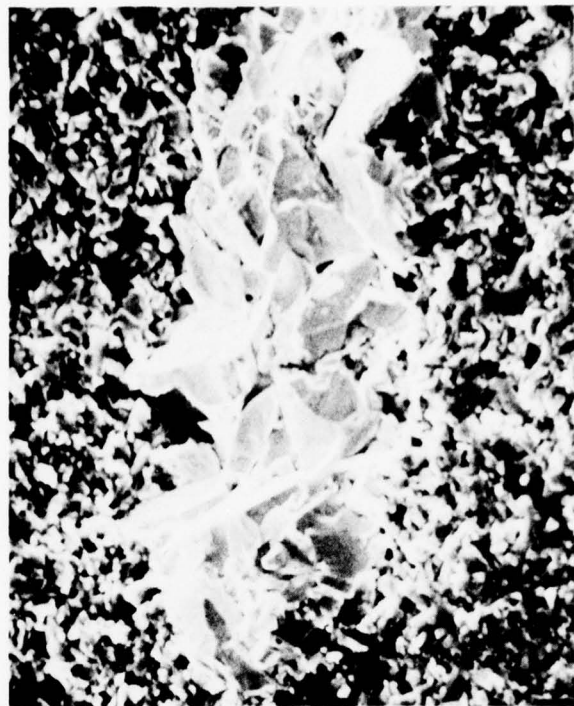
Figure 29. Fracture Surfaces of Ceralloy 147A Specimen 2 Showing Fracture Initiation Site.

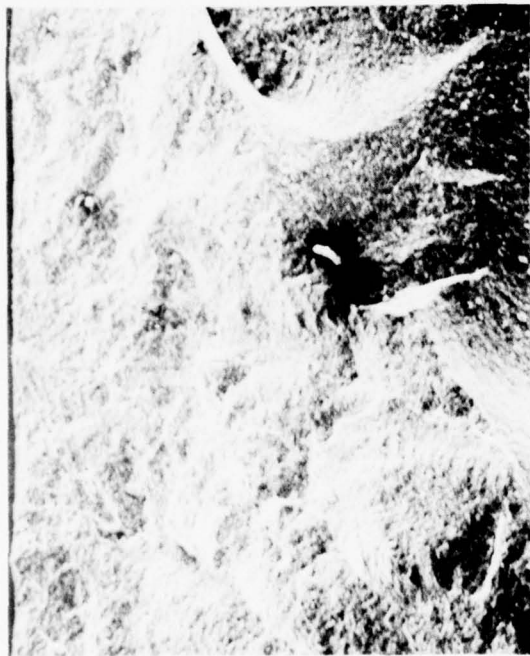
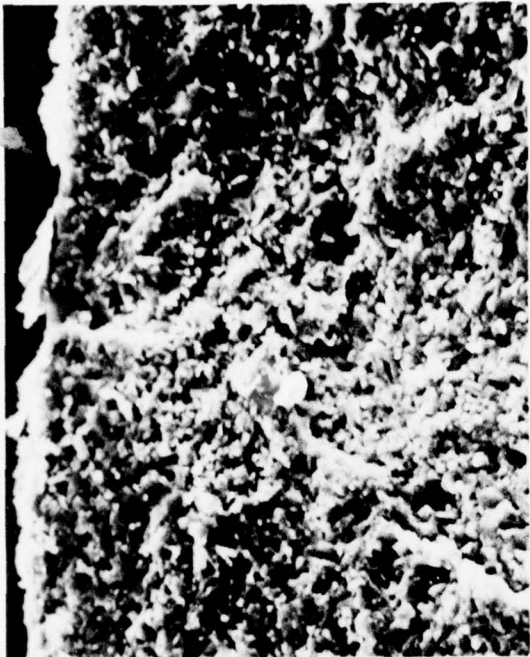
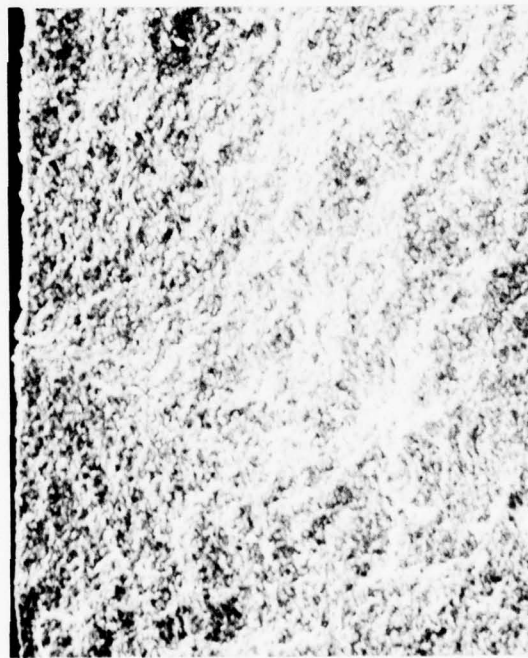
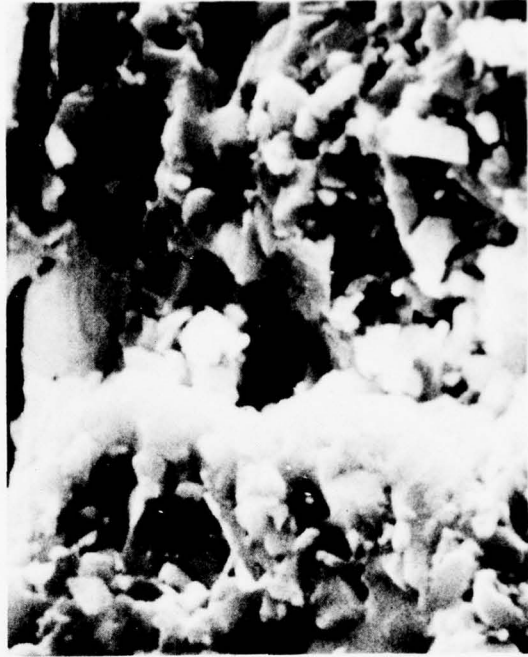
Figure 30. Fracture Surface of Ceralloy 147A Specimen
6 Showing Fracture Initiation Site.

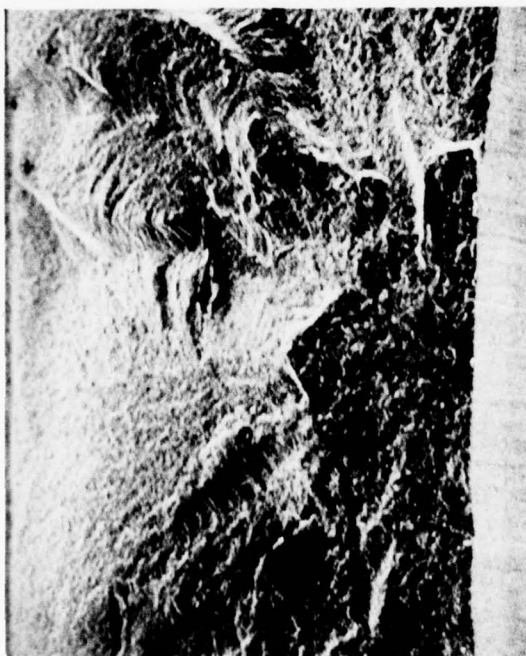
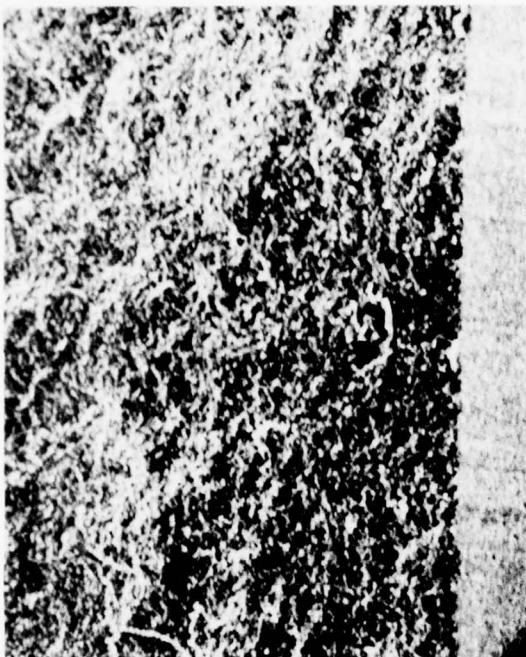
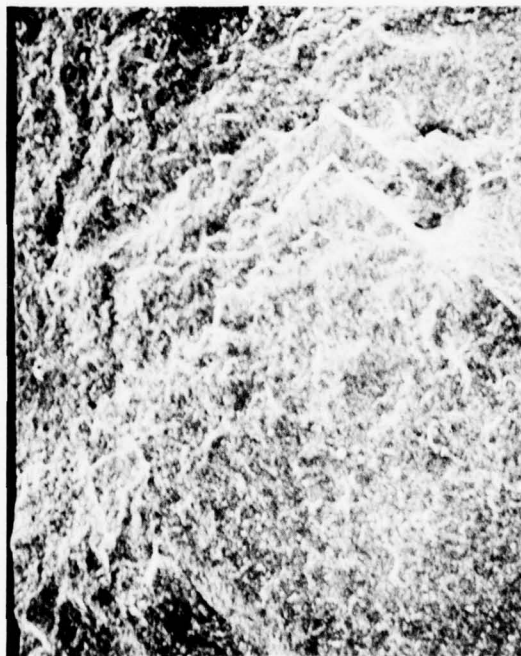
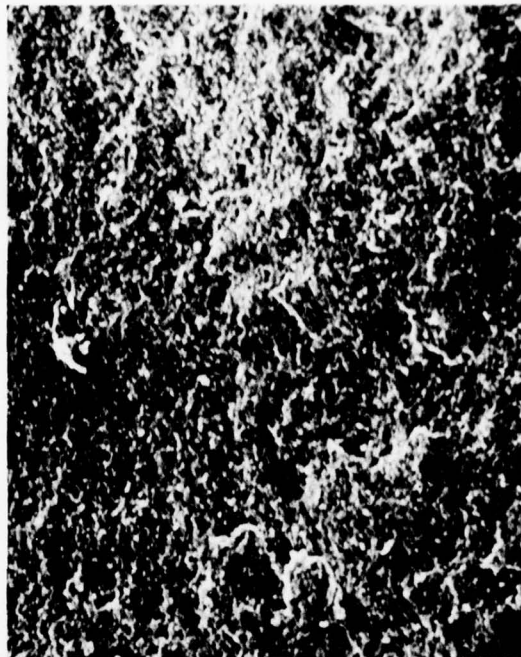
Figure 31. Fracture Surfaces of Ceralloy 147A Specimen
7 Showing Fracture Initiation Site.
